✓
DOT/FAA/CT-88/03FAA Technical Center
Atlantic City International Airport
N.J. 08405

Study of Benefits of Passenger Protective Breathing Equipment From Analysis of Past Accidents

Final Report

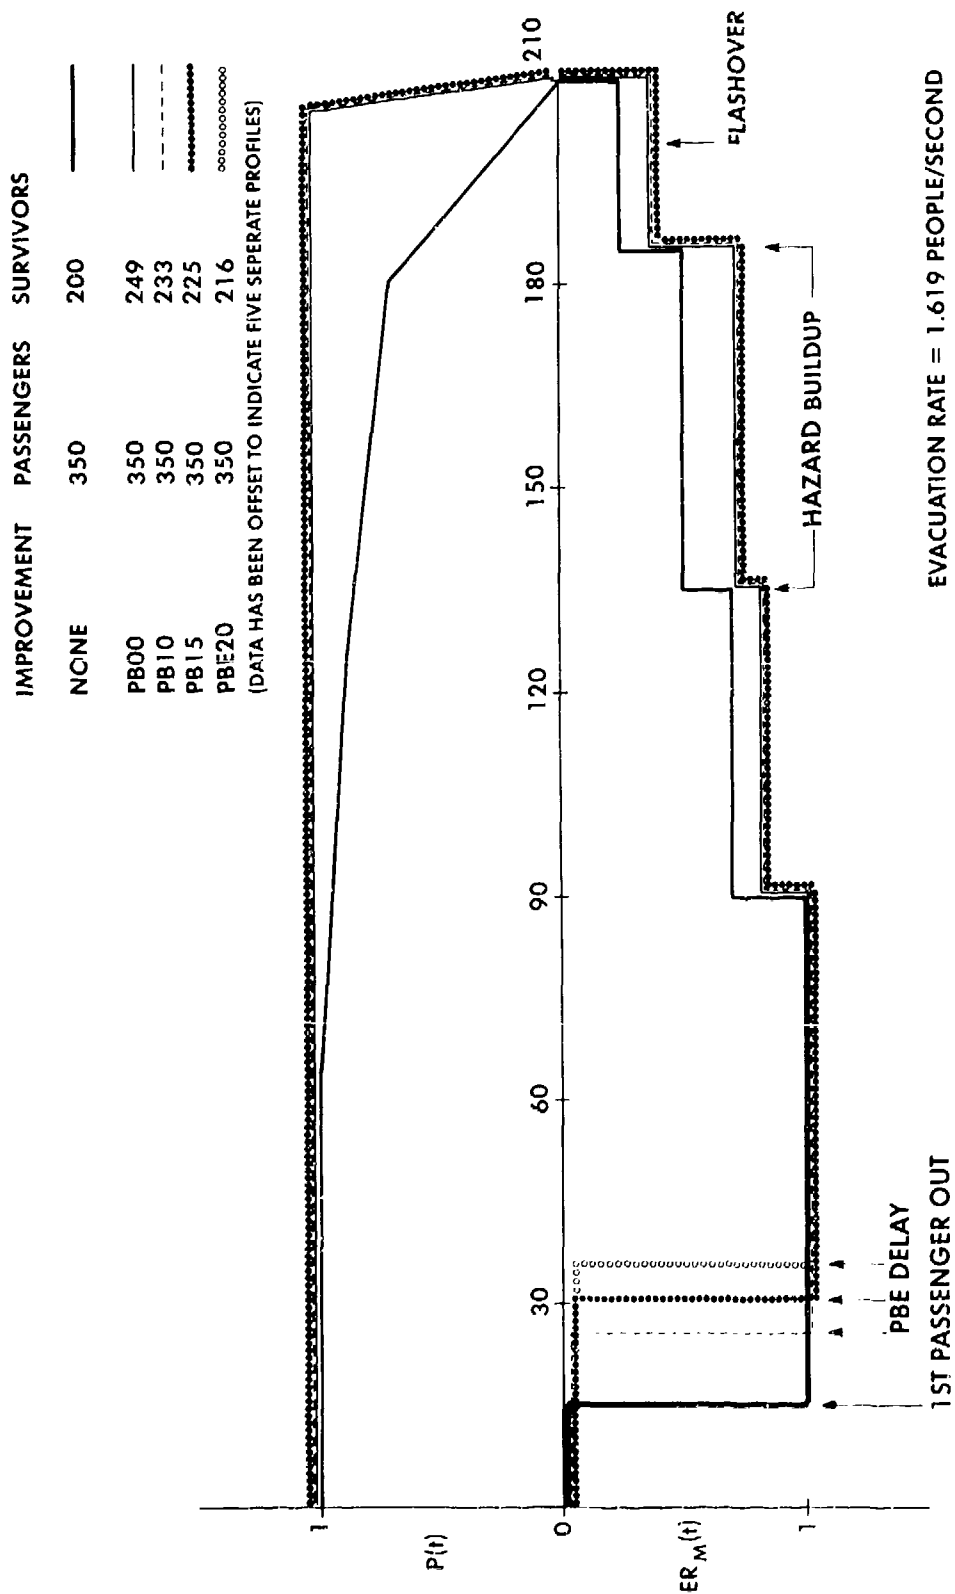
FIGURE 2. WIDE BODY PBE DELAY

The effect of this PBE delay is dependent on the duration and shape of the fire scenario hazard and mobility curves. For this scenario, PBE (zero delay) saved 49 people. However, delays in donning result in a linear loss of benefits; 10- and 20-second delays, respectively, result in 16 and 33 more fatalities than if masks were donned "instantly." This linear relationship of donning delays and additional fatalities does not hold, however, when the values of $P(t)$ or $ER_M(t)$ change during the donning periods. Donning delays have a great impact on survivability. The disbenefit from lengthy donning delays may be even greater than PBE benefits with no delay. Donning delay disbenefits occur during the beginning of the evacuation when $P(t)$ and $ER_M(t)$ are at their maximum values (highest evacuation rate of passengers). PBE benefits generally occur later in time when these values may be much lower (lowest evacuation rate).

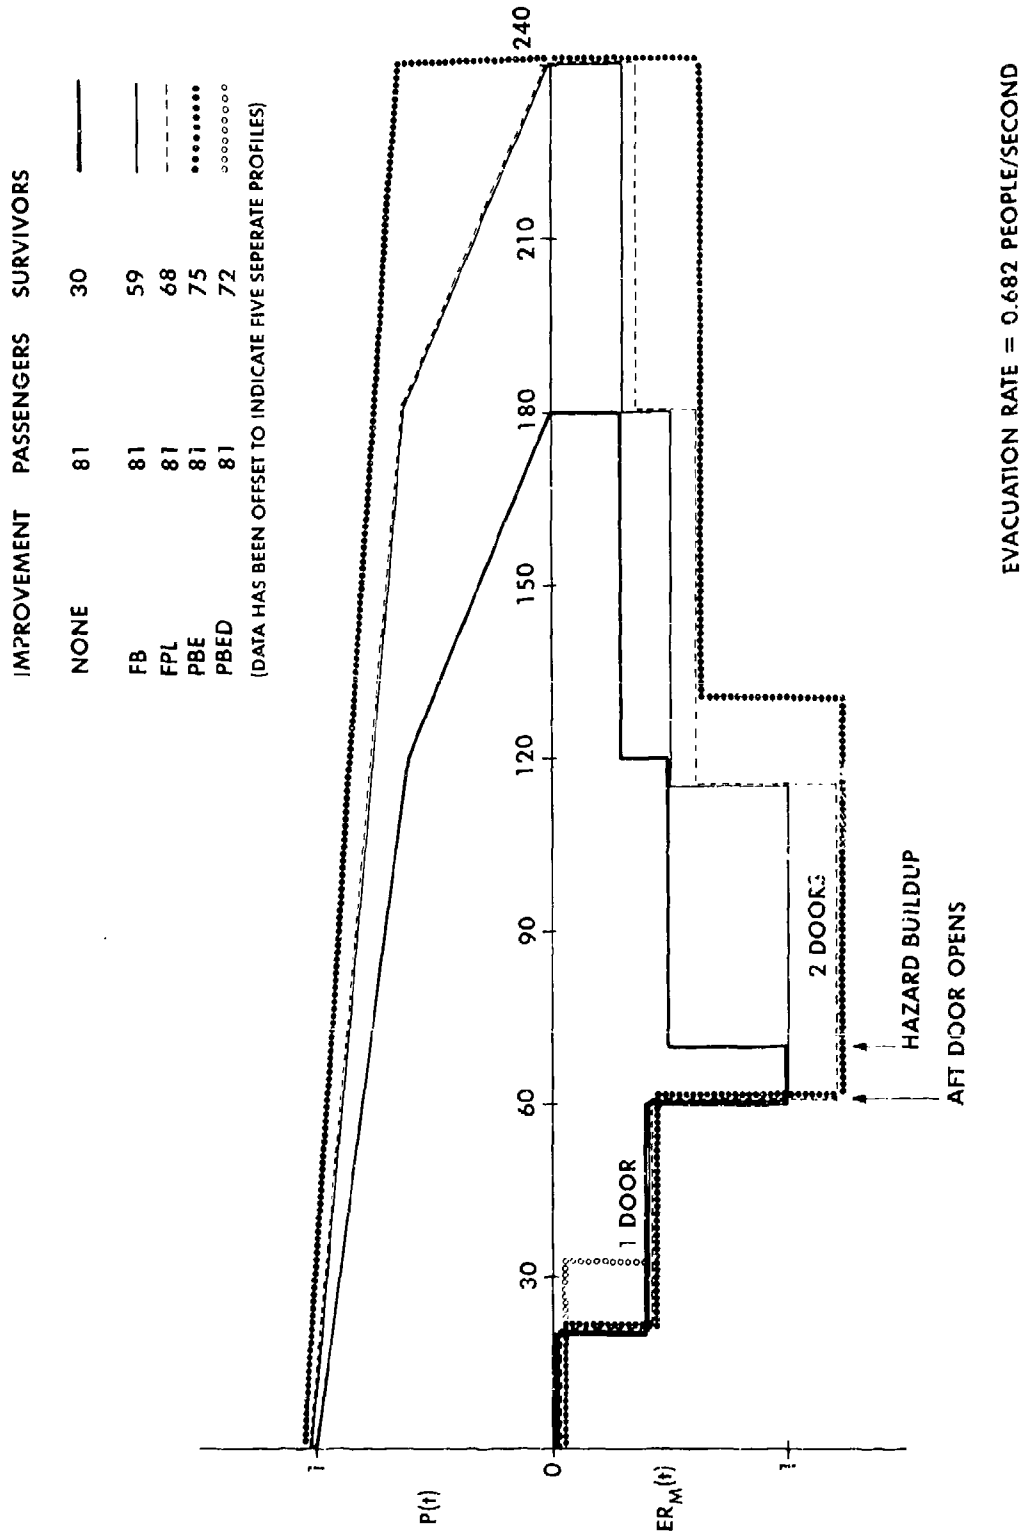
FIGURE 5. ACCIDENTS PROFILES FOR VARIG DC-8 3/5/67

This accident occurred at night and the cabin lights failed at impact. It was assumed that the first door opened at 20 seconds. The aft door opened after a long delay. A 60-second delay was assumed for this door. It was assumed the last person was out of the plane 3 minutes after it came to a stop. A 60-second FB benefit was assumed, since fire entered the fuselage during the evacuation through the window in the vicinity of seat rows 17 and 18. It also entered the fuselage through the open emergency exit, almost completely dividing the cabin at row 15. By delaying the fire involvement of seats, FB would delay the buildup of hazards in the aircraft cabin (thermal and toxic hazard profile) and the evacuation through each exit should proceed longer (mobility rate profile). An early benefit for FPL was assigned due to the combined effect of smoke and darkness. A modest survival benefit was assigned to PBE, recognizing other fire hazards existed in the aircraft. It was assumed PBE protection would have extended the time available to egress.

IMPROVEMENT	PASSENGERS	SURVIVORS
NONE	122	117
FB	122	117
FPL	122	121
PBE	122	122
PBED	122	122

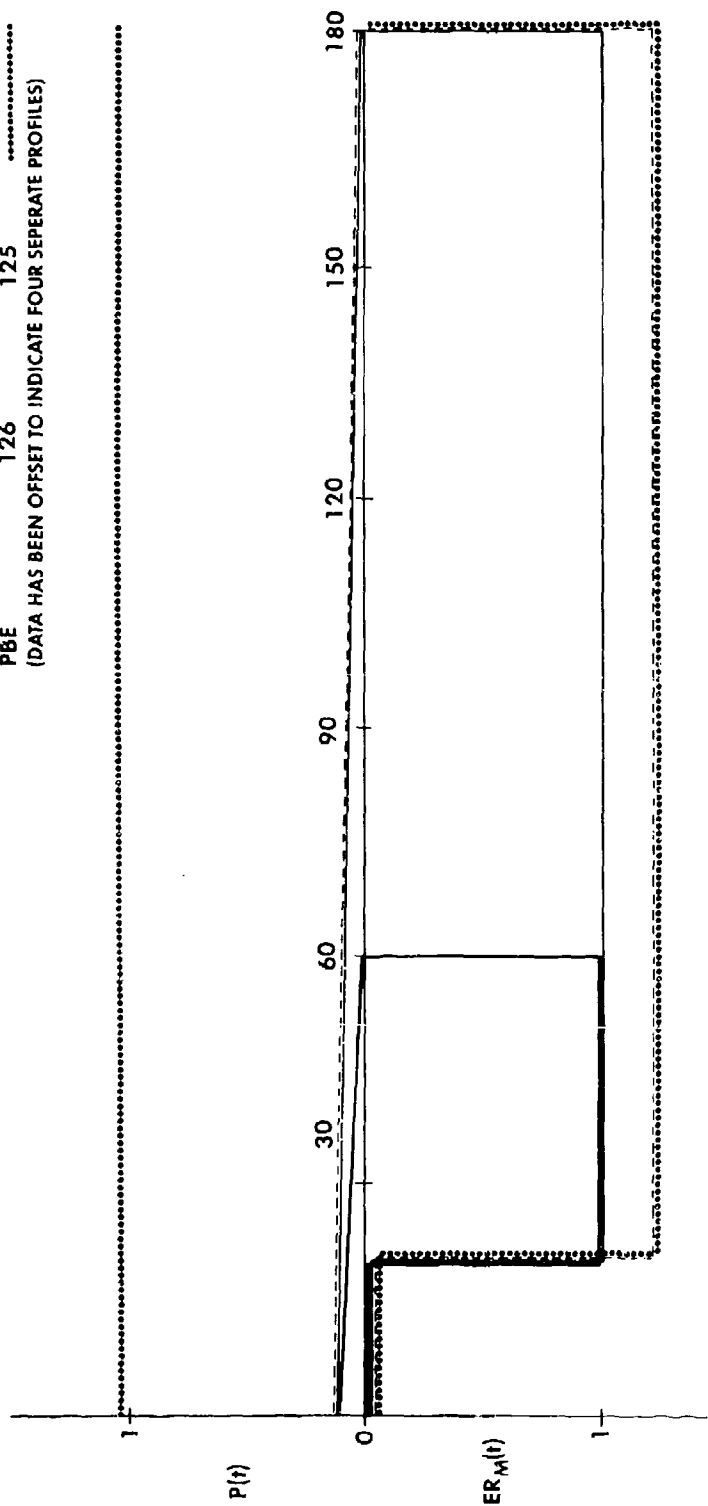
FIGURE 11. ACCIDENT PROFILES FOR VARIG B-707 7/11/73, NO EXTINGUISHERS

IMPROVEMENT	PASSENGERS	SURVIVORS
NONE	126	4
EXT	126	125

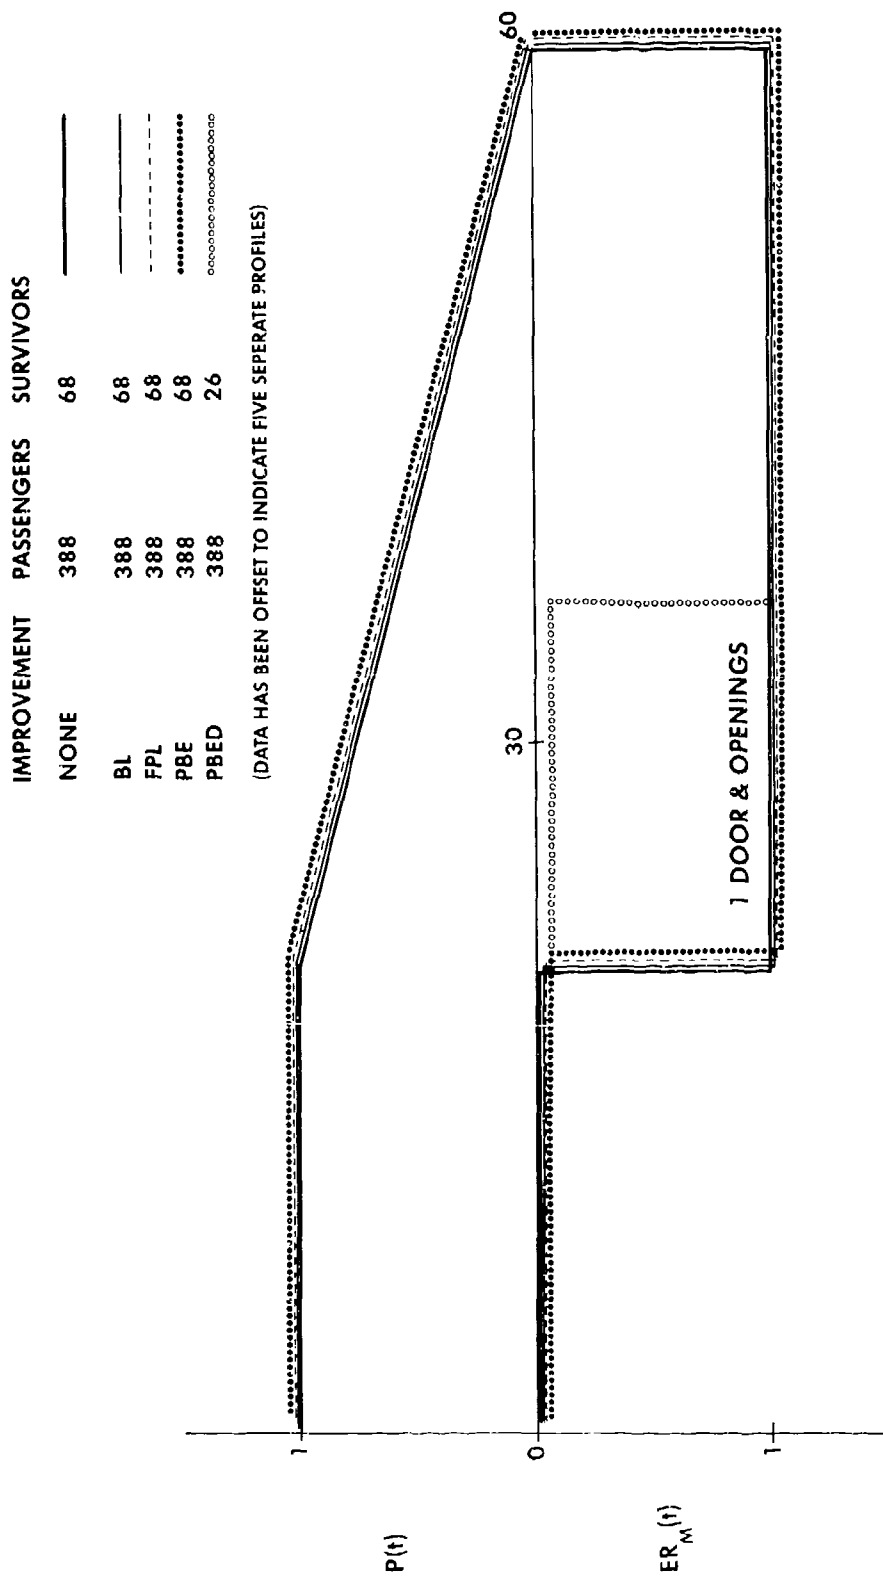
FIGURE 14. ACCIDENT PROFILES FOR PAN AM B-747 3/27/77

The aircraft was hit from above by a just airborne 747, leaving nearly the whole top open and an accumulation of wreckage in the center and aft. The evacuation time was estimated to be 1 minute in the accident report. Escape routes were L2 and openings on the left side. Explosions were taking place during the short evacuation. It was assumed the evacuation began at 20 seconds. No FB benefit was assigned as the explosions, flash fires, and pool fires dominated survivability. No FPL benefit was assigned as the top of the fuselage was ripped open. No PBE benefit was assigned since other hazards probably predominated. The disbenefit for a 15-second donning delay is high (42 lives) due to the short escape time, however, it is unlikely PBE would be donned under the conditions of this accident.

IMPROVEMENT	PASSENGERS	SURVIVORS
NONE	197	195
FB	197	195
FPL,PBE	197	195
PBED	197	195

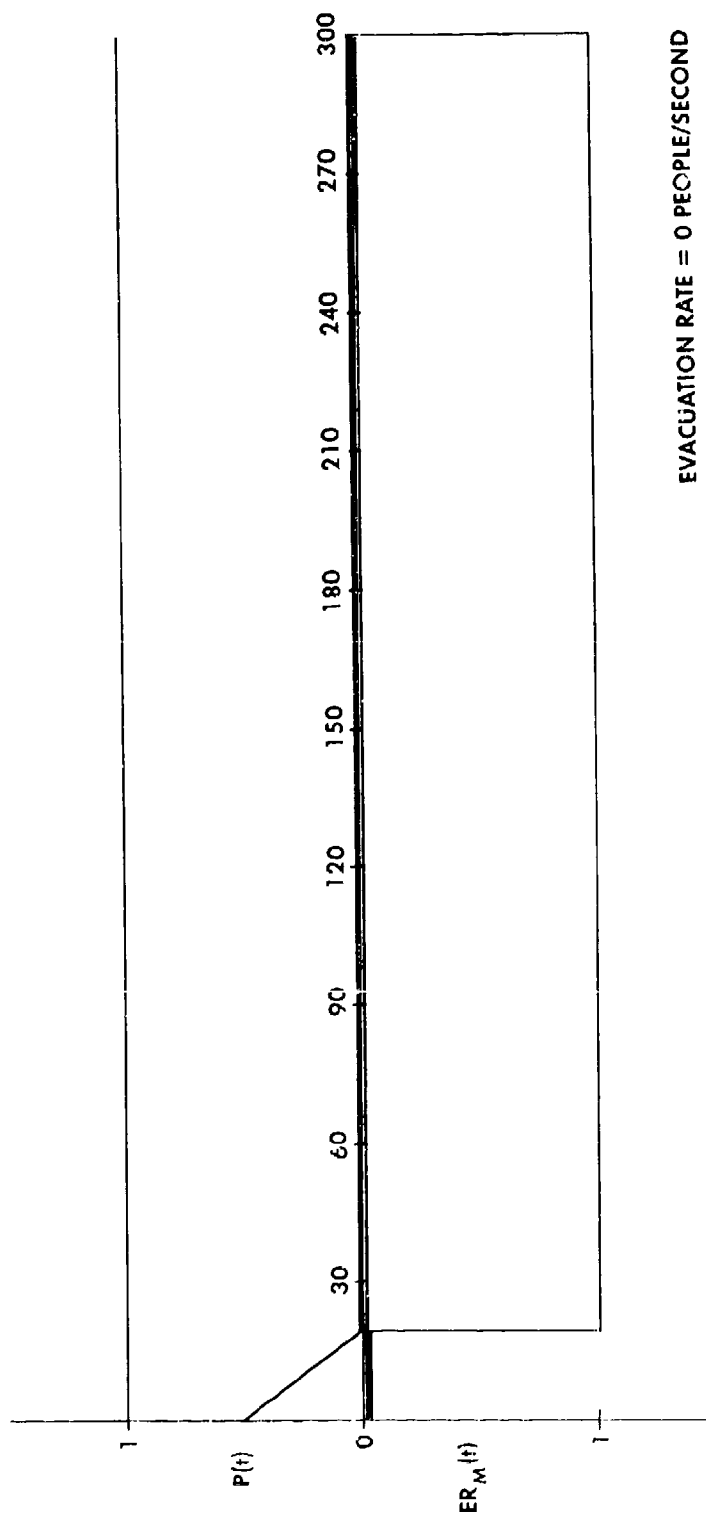
FIGURE 16. ACCIDENT PROFILES FOR SAUDI L1011 8/19/80

FB would have saved all aboard the 1980 Saudi Air accident. It was assumed FB would have prevented this type of fire because the fire burned into the cabin through the floor. It was demonstrated in the C133 test article that FB would prevent underseat fires from spreading. The analysis also predicts that FB, by delaying seat fire involvement, would have saved all fatalities in the 1983 Air Canada, 1980 Korean Airlines, and 1982 Spantax accidents. In total, 10 of the 20 accidents would have had additional lives saved if FB had been installed.

IMPROVEMENT	PASSENGERS	SURVIVORS
NONE	223	211
FB	223	223
FPL	223	223
PBE	223	223
PBED	223	223
